# Durability of GFRP Composite Rods

Results from preliminary field tests don't match data from accelerated lab tests

BY AFTAB MUFTI, NEMKUMAR BANTHIA, BRAHIM BENMOKRANE, MOHAMED BOULFIZA, AND JOHN NEWHOOK

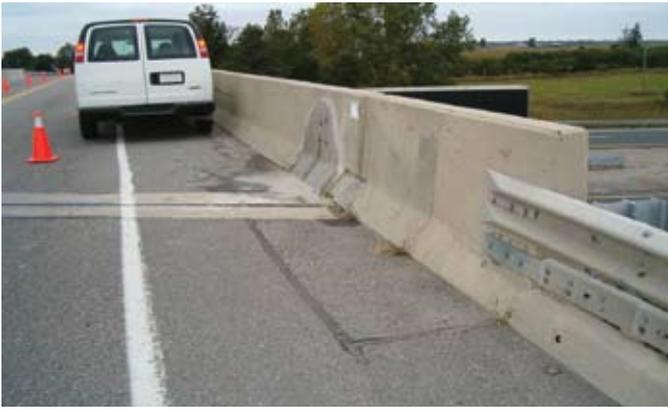
**Fig. 1: Cores were taken from the barrier wall of the Chatham Bridge in Chatham, ON, Canada**

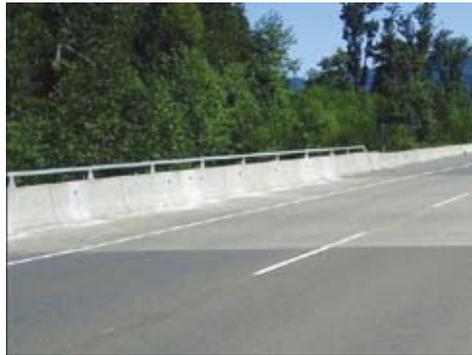
**Fig. 2: Cores were taken from the barrier wall of the Waterloo Creek Bridge on Vancouver Island, BC, Canada**

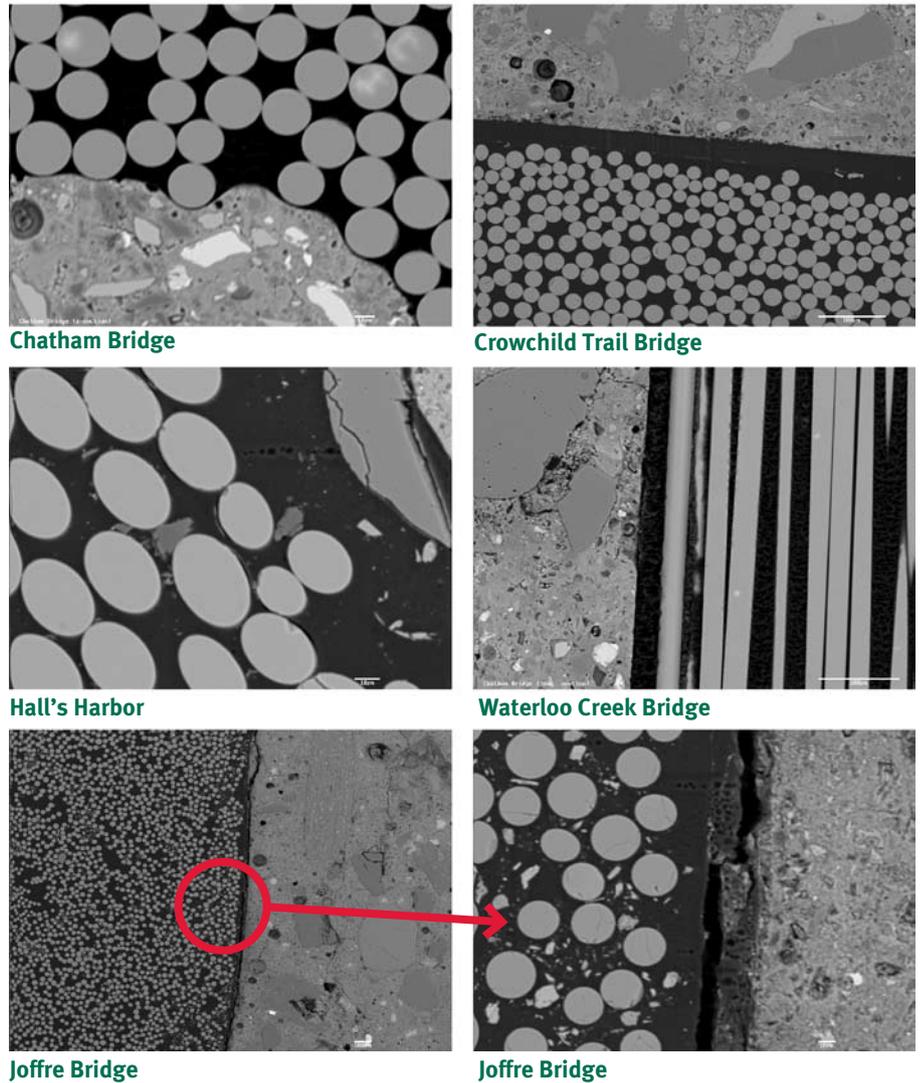
SEM was used to visually examine the effects of exposure at a high magnification on the constituent materials of the GFRP. Typical SEM micrographs are shown in Fig. 3. In each of the five structures, there was no sign of any damage to the GFRP. None of the fibers lost any cross-sectional area, and no degradation of the fibers was visible. Furthermore, individual fibers were intact with no gaps between the fibers and the matrix. There was also no evidence of deterioration at the glass/matrix interface—good contact was noted between individual glass fibers and the surrounding polymer matrix as well as between the sand grains and the matrix. Although drying in the SEM chamber can lead to interfacial damage and therefore make it difficult to observe the integrity of

the FRP-concrete bond, examination with an optical microscope indicated that good contact was maintained at the FRP-concrete interface.<sup>10,12</sup>

**Fig. 3: Scanning electron micrographs of GFRP extracted from each structure indicated no signs of deterioration in the fibers or polymer matrix. The visible interfacial damage is apparently the result of drying in the SEM chamber, as no such damage was observed using an optical microscope**

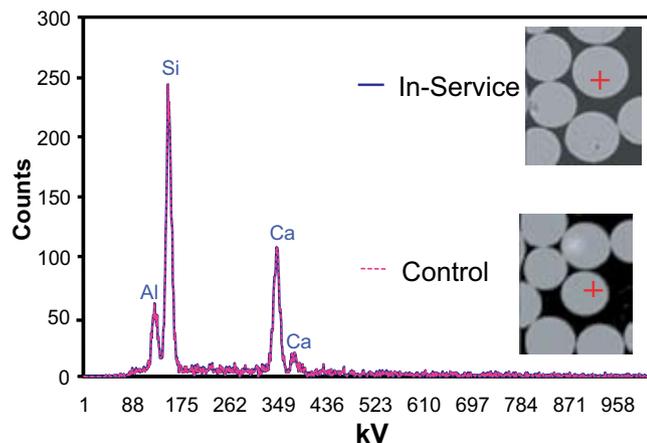
In Fig. 4, the EDX plot for in-service glass fiber from the Hall’s Harbor Wharf is compared with the plot for companion control GFRP rods stored under controlled conditions in the laboratory. The chemical composition of fibers in each rod showed the absence of zirconium (Zr), thus confirming that the investigated GFRP contained E-glass and not alkali-resistant (AR) glass. This was true for all structures. Figure 4 also shows that the EDX plots for glass fiber in in-service GFRP samples were virtually identical to those for control specimens. This indicates that there was no deterioration of the glass fiber. In Fig. 5, EDX plots for the polymeric matrix from the in-service GFRP in the Joffre Bridge are compared with control GFRP bars kept under controlled conditions in the laboratory. The two spectra are alike, indicating that no deterioration occurred in the field. As expected, the matrix in both specimens contained mainly carbon (C); however, some additional elements such as silicon (Si), aluminum (Al), and calcium (Ca) were also detected.

**Fig. 4: EDX scans for in-service and control glass fibers from Hall’s Harbor Wharf**

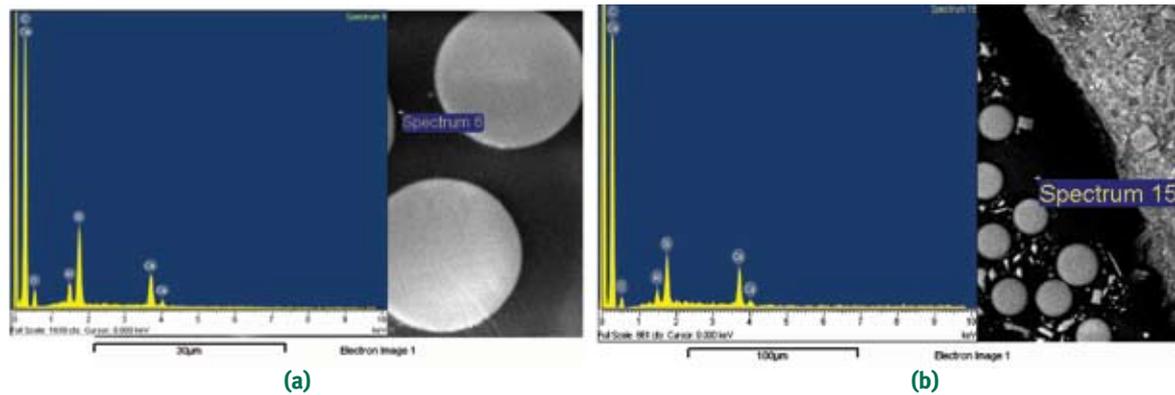
Fig. 5: EDX scans for the polymer matrix from the Joffre Bridge: (a) in-service matrix; and (b) control matrix

dissolution, leaching, and ion exchange, the chemical compositions of the glass and matrix change. The concrete pore solution consists mainly of sodium ( $\text{Na}^+$ ) and potassium ( $\text{K}^+$ ) ions with hydroxyl ions ( $\text{OH}^-$ ) as counter ions. Other elements present in the solution are either very insoluble, such as calcium ions ( $\text{Ca}^{2+}$ ), or have low solubility such as magnesium (Mg), aluminum (Al), silicon (Si), iron (Fe), and sulfate ions ( $\text{SO}_4^{2-}$ ). Because the EDX can't detect elements lighter than sodium (Na), the  $\text{OH}^-$  cannot be detected. The  $\text{OH}^-$  and cations ( $\text{Na}^+$ ,  $\text{K}^+$ ), however will diffuse together for charge neutrality to be satisfied. Therefore, a strong indication of alkali migration from concrete pore solution toward the glass fibers would lead to the presence of Na or K in the matrix. Observations on several specimens indicated that neither Na nor K was present in the matrix (Fig. 5).

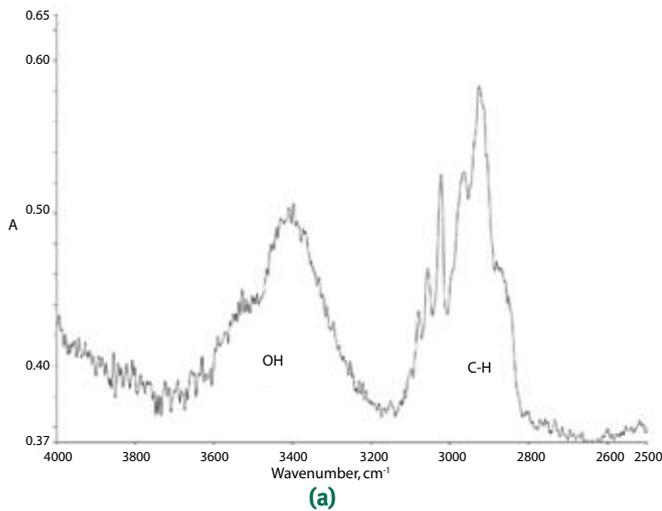
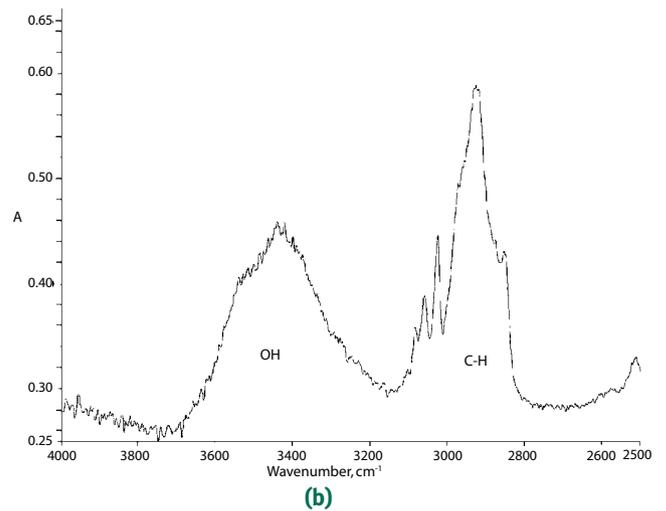
Fig. 6: FTIR spectra for GFRP in the Joffre Bridge: (a) in-service GFRP; and (b) control GFRP

into powder. The pellet method with spectroscopic grade potassium bromide (KBr) was used to obtain the infrared spectra. The relative amounts of hydroxyl groups in the specimens were measured by determining the ratio of the maximum of the band corresponding to the hydroxyl groups (at a wavenumber of  $3430\text{ cm}^{-1}$ ) and the band corresponding to the carbon-hydrogen groups (at a wavenumber of  $2900\text{ cm}^{-1}$ ) in the FTIR spectra. The C-H content was assumed to be constant. Because the vinyl-ester resins naturally contain hydroxyl groups, all the spectra present a strong absorption band in this region. Typical results of the FTIR analysis for control and in-service GFRP samples from the Joffre Bridge are presented in Fig. 6 and show that there was no significant change in the spectra of the specimens. Similar conclusions were drawn for rods from other structures.

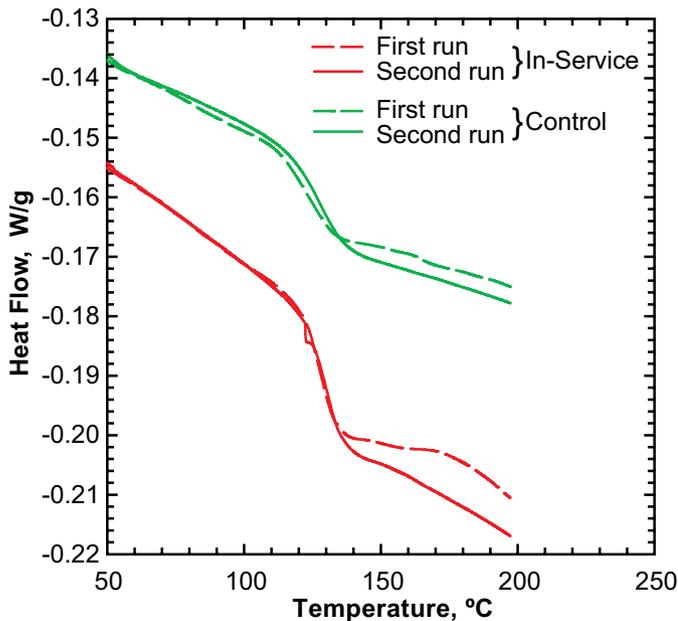
**Fig. 7: DSC results for the in-service and control polymer matrix in GFRP from the Joffre Bridge. The  $T_g$  for the matrix is indicated by the sharp drop in the curves**

The  $T_g$  measurements were carried out on small pieces cut from GFRP extracted from the cores. The measurements were taken in air between  $40$  and  $200\text{ }^\circ\text{C}$  ( $104$  and  $392\text{ }^\circ\text{F}$ ) at a heating rate of  $10\text{ }^\circ\text{C/minute}$  ( $18\text{ }^\circ\text{F/minute}$ ). Typical results are given in Fig. 7. There was no appreciable difference between the glass transition temperature for in-service GFRP and control GFRP. Similar conclusions were drawn for all other structures.
